DEPARTMENT OF TRANSPORTATION**DIVISION OF ENGINEERING SERVICES**

Quality Assurance and Source Inspection

Contract #: 04-0120F4Cty: SF/ALA Rte: 80 PM: 13.2/13.9File #: 69.15**SOURCE INSPECTION REPORT****Resident Engineer:** Pursell, Gary**Address:** 333 Burma Road**City:** Oakland, CA 94607**Report No:** SIR-000047**Date Inspected:** 18-Apr-2007**Project Name:** SAS Superstructure**OSM Arrival Time:** 800**Prime Contractor:** American Bridge/Fluor Enterprises, a JV**OSM Departure Time:** 1530**Contractor:** Zhenhua Port Machinery Company, Ltd (ZPMC), Changxing Island **Location:** Shanghai, China**Quality Control Contact:** Lu Jian Hua**Quality Control Present:** Yes No**Material transfer:** Yes No N/A**Sampled Items:** Yes No N/A**Stock Transfer:** Yes No N/A**OK to Cut:** Yes No N/A**Rebar Test Witness:** Yes No N/A**Delayed/Cancelled:** Yes No N/A**Other:** NA**Bridge No:** 34-0006**Component:** NA**Bid Item:** 52, 55**Lot No:** NA**Summary of Items Observed:**

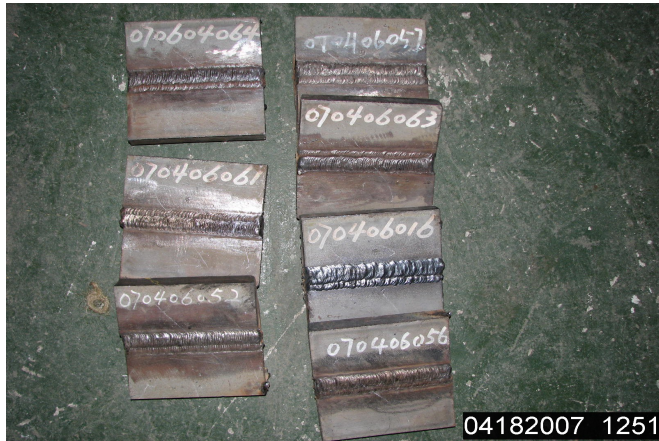
At 1100 hour, ZPMC QA Inspector, Mr. Lu Jian Hua presented welder qualification radiographs for review. Caltrans Lead Inspector, Mr. David McClary reviewed the film. Mr. McClary observed seven radiographs, identified as 070406016, 070406052, 070406056, 070406057, 070406061, 070406063 and 070604064 with objectable film. The radiographs showed weld reinforcement with surface irregularities that may obscure discontinuities in the radiograph.

Mr. McClary met ABF representative, Mr. Nathan Lindell in regards to the quality of the radiographs for film interpretation. Mr. Lindell reviewed the radiographs and concurred with Mr. McClary concerns with the radiographs. Mr. McClary and Mr. Lindell met with Mr. Lu and questioned him about weld reinforcement and the concerns about interpretation of such radiographs. Mr. Lu stated that ZPMC radiographic personnel visually examined the test plates prior to xraying and had removed weld reinforcement with questionable weld profile to facilitate in the interpretation of the film. Caltrans QA asked Mr. Lu if the test plates that were xrayed were available, to verify, that test plates were selected and ground to aid in the interpretation of the film. Mr. Lu directed Caltrans QA, Mr. McClary and Mr. Lindell to where the test plates were being stored. After a visual inspection of the test plates, it appeared that none of the test plates had any weld reinforcement removed. Mr. Lu then explained that ZPMC QA requested ZPMC xray personnel visually inspect test plates with questionable weld profiles and removed the reinforcement by grinding to a smooth finish. Mr. McClary asked Mr. Lindell and Mr. Lu, if Moody International has reviewed the film, prior to presenting them to Caltrans for review. Mr. Lu stated that Moody has not reviewed the film, due to Moody not being available until Saturday, April 21, 2007. Mr.

McClary informed Mr. Lindell that Moody International is to review radiographs prior to presenting them to Caltrans for review.
